INDEX OF TEXAS ARCHAEOLOGY

Investigation and Recovery of USS Westfield (Site 41GV151) Galveston Bay, Galveston County, Texas

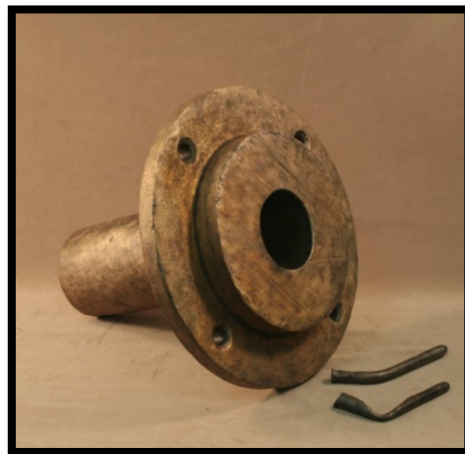
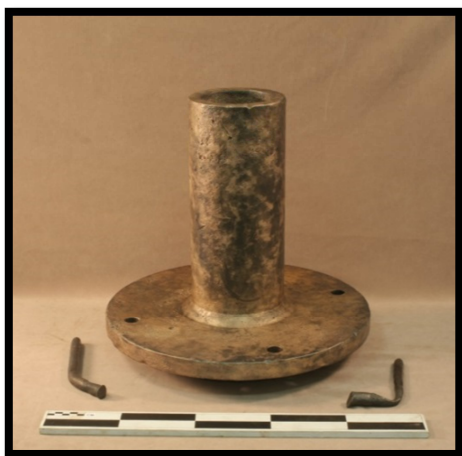
FIGURE 207. *WESTFIELD* DECK SOCKET FOR PIVOT CARRIAGE (ARTIFACT 122-046)

FIGURE 206. *WESTFIELD* DECK SOCKET FOR PIVOT CARRIAGE (ARTIFACT 122-046; SCALE CM/DM)

1863 (*Houston Tri-Weekly Telegraph* 1863a). A heavy brass deck socket for a pivot carriage (Artifact 122-046; figures 206 and 207) was recovered near the rear cabin bulkhead. This was presumably associated with the pivot Dahlgren mounted at the stern. An example of how the pivot socket would have been incorporated into the main deck is shown in the right foreground of Figure 208. It is unclear how such a heavy artifact, its shaft originally embedded in the main deck, moved forwards the length of the aft deck before sinking to the seafloor. One possible scenario is that a section of deck containing the socket detached under its weight as the vessel burned but retained sufficient buoyancy to float forward until coming to rest near the cabin bulkhead.

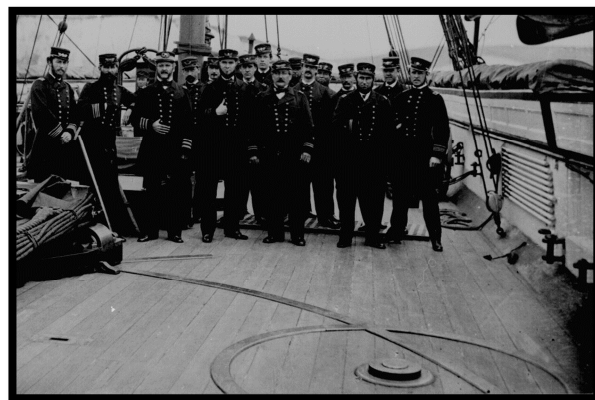
FIGURE 208. SOCKET FOR PIVOT CARRIAGE IN DECK OF UNIDENTIFIED GUNBOAT.

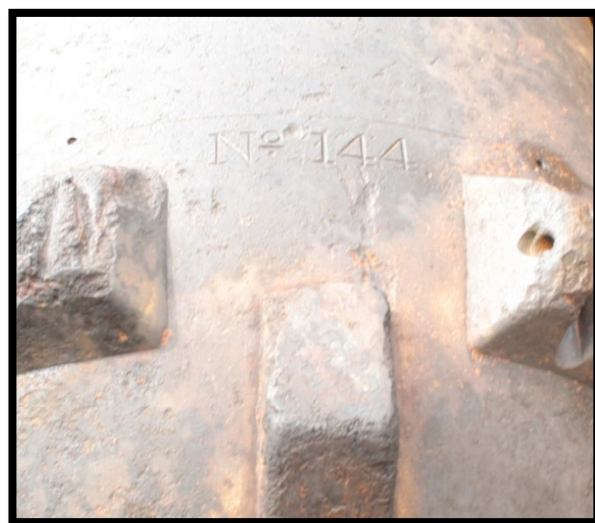
FIGURE 209. *WESTFIELD* DAHLGREN SERIAL NUMBER (ARTIFACT 123-001)

The *Westfield* Dahlgren's government serial number, No. 144, is stamped on top of the gun just forward of the gun sight position (Figure 209). The gun was cast at the Cyrus Alger and Company foundry in south Boston in 1857 (Olmstead, et al. 1997:243). The serial number might ultimately be used to establish the origin of the recovered Dahlgren, as originally belonging either to *Westfield* or borrowed from *Clifton*. The authors suspect, based on its location within the debris field, that the recovered Dahlgren was positioned in the broadside gun port immediately aft of the cabin on the starboard side when the ship was destroyed. Since *Westfield*'s original Dahlgren was pivot-mounted at the stern, this position implies that the recovered gun was mounted on a Marsilly carriage and was the gun borrowed from USS *Clifton*, although that determination has yet to be confirmed by research. The conserved Dahlgren is illustrated in Figure 210 as it now appears on a reconstructed Marsilly carriage.

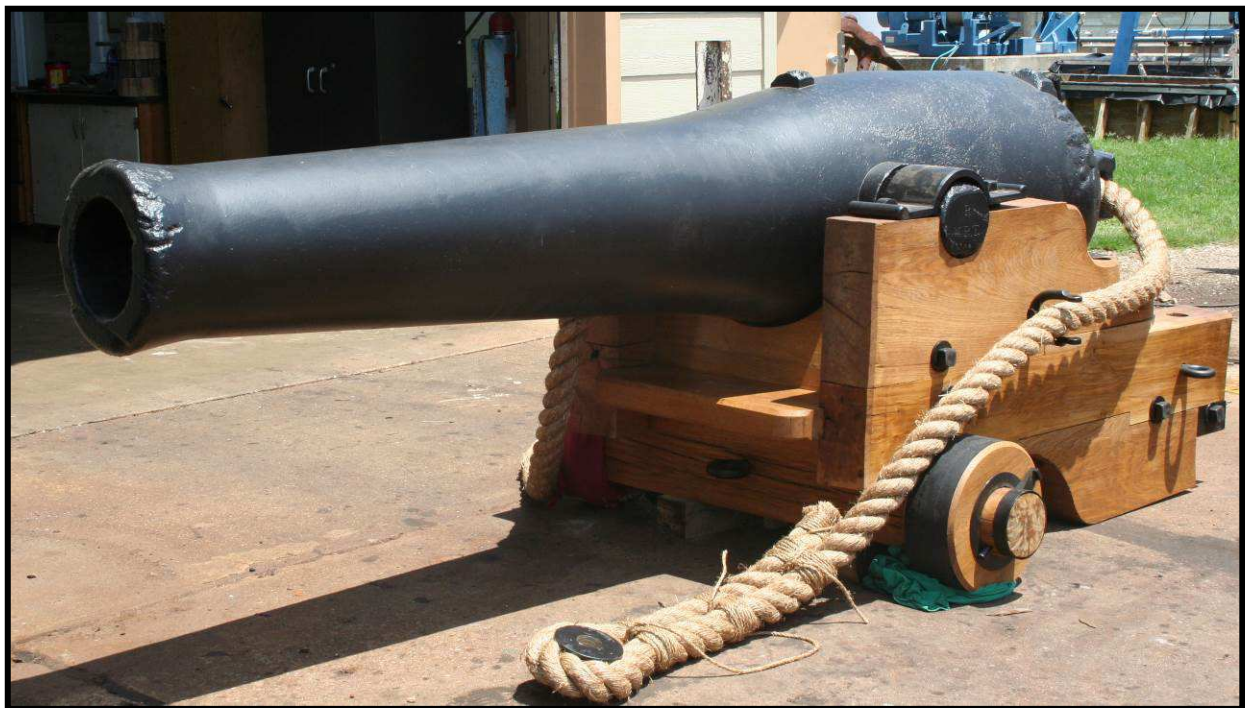
FIGURE 210. *WESTFIELD* 9-INCH DAHLGREN ON RECONSTRUCTED MARSILLY CARRIAGE (ARTIFACT NO. 123-001)

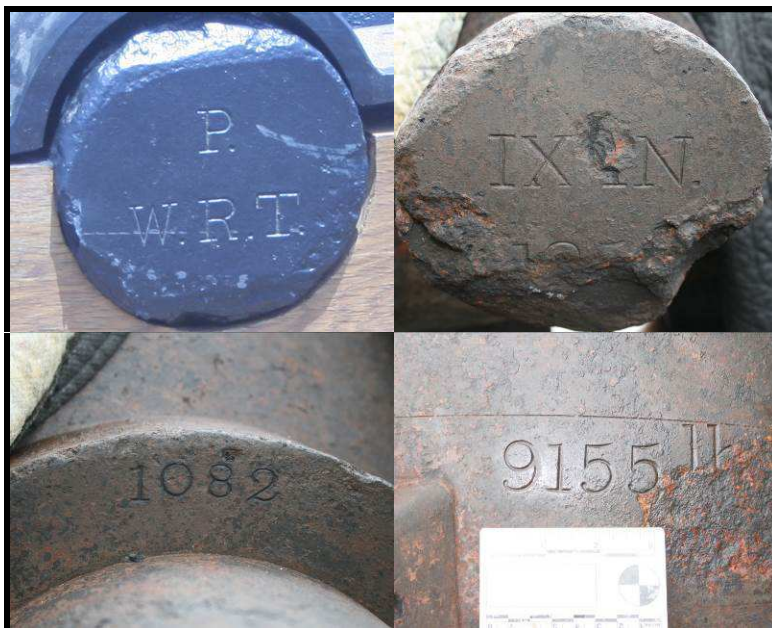
FIGURE 211. IDENTIFYING STAMPS ON WESTFIELD'S 9-INCH DAHLGREN

The left trunnion is stamped “P” for proof and “WRT” (Figure 211), indicating that the gun was inspected at the foundry by William R. Taylor in his first year working at the Alger foundry (Olmstead, et al. 1997: 170). The right trunnion is marked “IX IN” for 9-inch Dahlgren. The Alger foundry casting number “1082” is stamped on the rimbase of the right trunnion (Figure 211) and on the top of the cascabel as stipulated by The Bureau of Ordnance (Unidentified 1881:331). Just forward and to the side of the left firing mechanism is stamped the cannon’s weight, “9155” pounds. The foundry’s initials, located on the base line just to the side of the right ignition base, have eroded away.

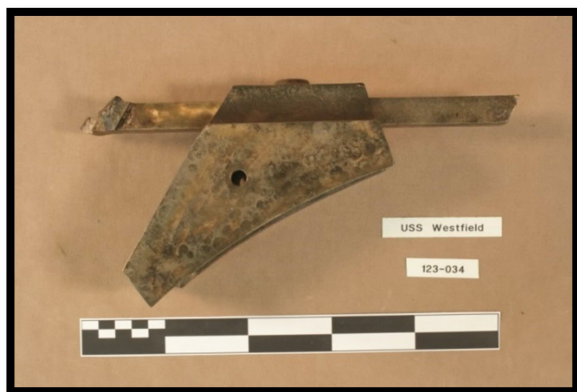
FIGURE 213: DAHLGREN REAR GUN SIGHT (SIDE)
(ARTIFACT 123-34; SCALE CM)

The Dahlgren's rear gun sight (figures 213 and 214) was recovered from sediment directly beneath the cannon. Both pieces are stamped with the Dahlgren's government serial number, 144. The bent firing hammer (figures 215 and 216) was attached to the Dahlgren when it was recovered and, likewise, is stamped with serial number 144. A coil of well-preserved cord, believed to be the Dahlgren's hammer cord (Figure 217), was recovered from inside the cannon's muzzle. A more

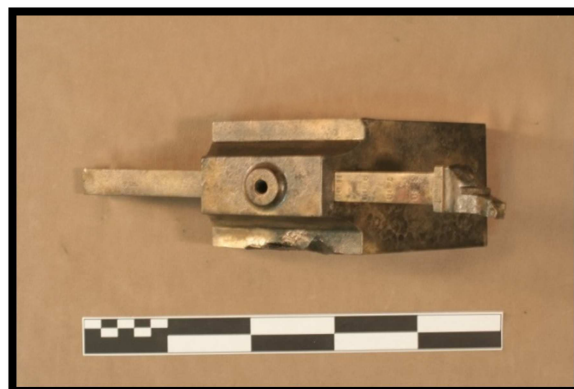
FIGURE 214: DAHLGREN REAR GUN SIGHT (TOP)
(ARTIFACT 123-34; SCALE CM)

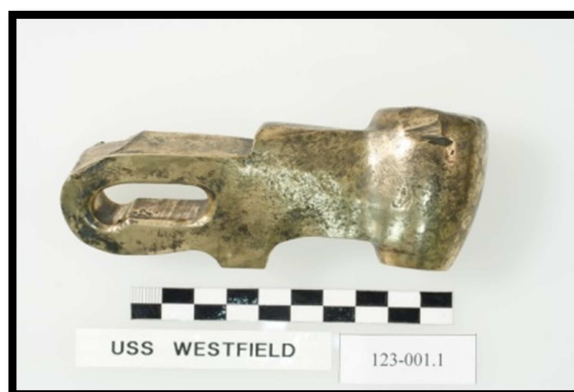
FIGURE 215: DAHLGREN FIRING HAMMER (SIDE)
(ARTIFACT 123-001.1)

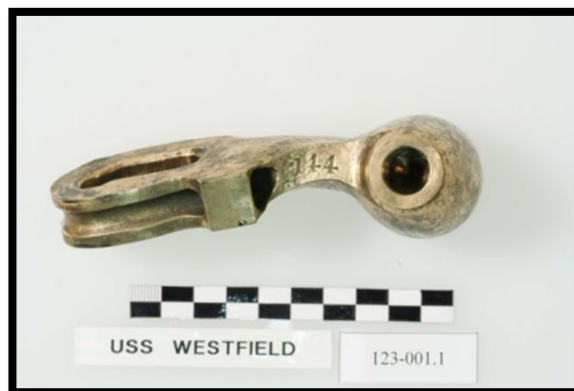
FIGURE 216: DAHLGREN HAMMER (BOTTOM)
(ARTIFACT 123-001.1)

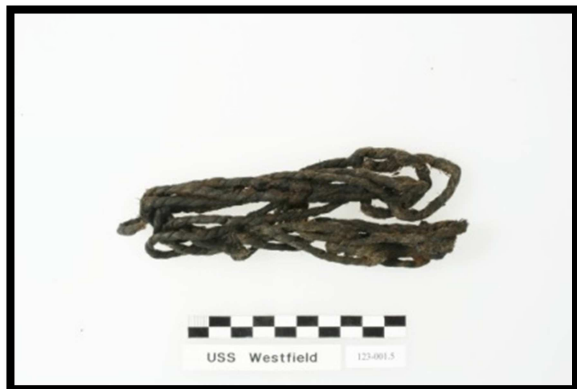
FIGURE 217: DAHLGREN HAMMER CORD
(ARTIFACT 123-001.5)

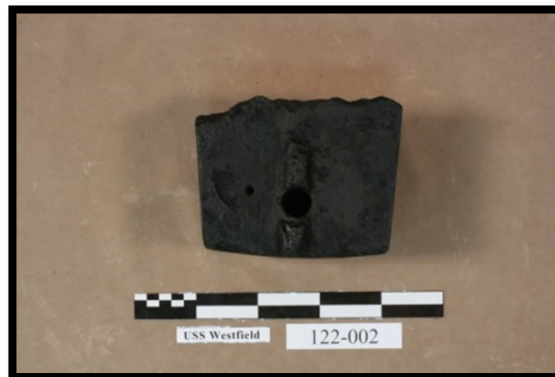
FIGURE 220: DAHLGREN CASCABEL BLOCK (TOP)
(ARTIFACT 122-002; SCALE CM)

Several artifacts recovered from the site in the vicinity of the cannon have been identified as parts of a gun carriage or associated tackle. Details from the Brady Collection photograph shown in Figure 204 are enlarged in Figure 212 to illustrate the function of various artifacts recovered from the site including: a rear gun sight (figures 213 and 214; compare Figure 212-A); a firing hammer and hammer cord (figures 215, 216 and 217; compare Figure 212-B); a fragment of an elevation screw (Figure 218; compare Figure 212-C); and a cascabel block, attached when recovered, used to secure the breach rope (figures 219 and 220; compare Figure 212-D).

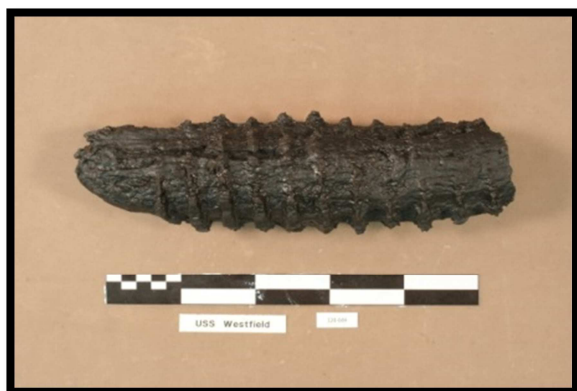
FIGURE 218: DAHLGREN ELEVATION SCREW
(ARTIFACT 124-049; SCALE CM)

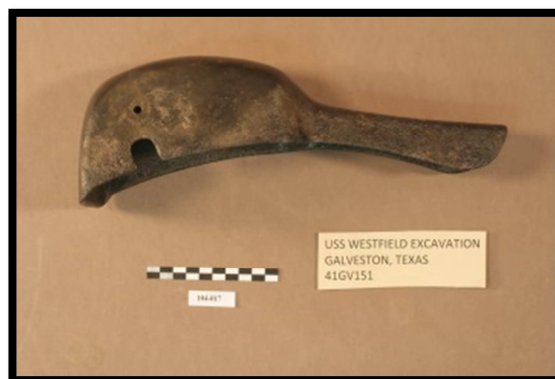
FIGURE 221. REAR GUN SIGHT COVER
(ARTIFACT 104-17)

A rear gun sight cover (Figure 221) was recovered about 30 ft aft of the Dahlgren. It is 12 x 2 $\frac{5}{8}$ x 3 inches and marked "PF 8 OF 56." Its style matches site covers used on Dahlgren cannons (Figure 222, for example); however, it does not quite fit over the recovered gun sight. This artifact might be associated with the other Dahlgren, which was recovered by Confederate salvers in 1863.

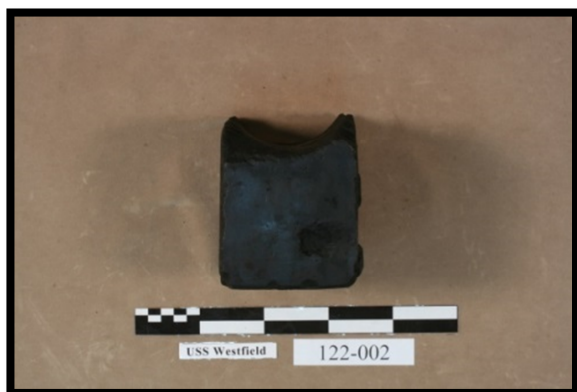
FIGURE 219: DAHLGREN CASCABEL BLOCK (SIDE)
(ARTIFACT 122-002; SCALE CM)

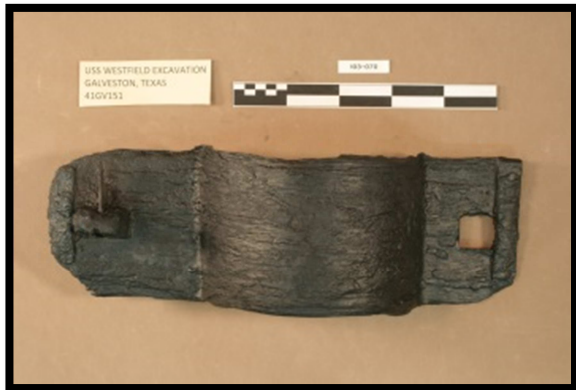
FIGURE 224. CAP SQUARE
(ARTIFACT 103-070; SCALE CM)

Details of a historic Marsilly gun carriage (Figure 223) show three examples of gun carriage tackle resembling artifacts recovered from the site including a cap square (Figure 224; compare Figure 223-A); a breach rope guide (Figure 225; reproduction based on radiographic image in Figure 63; compare Figure 223-B) and an eyebolt (Figure 226; Figure 223-C). The cap square is clearly from a gun carriage, though not necessarily a Marsilly type. It was found about 40 ft aft of the cannon and within about 17 ft of the gun sight cover. It is possible that both the cap square and the sight cover might have been associated with the Dahlgren pivot cannon mounted on the stern.

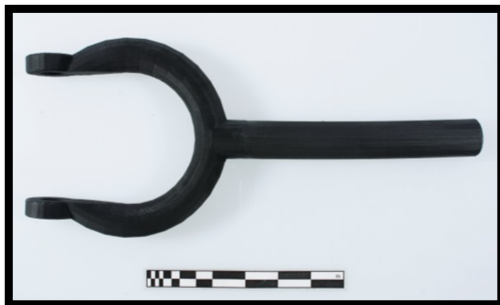
FIGURE 225. BREACH ROPE GUIDE
(ARTIFACT 107-014; SCALE INCHES)

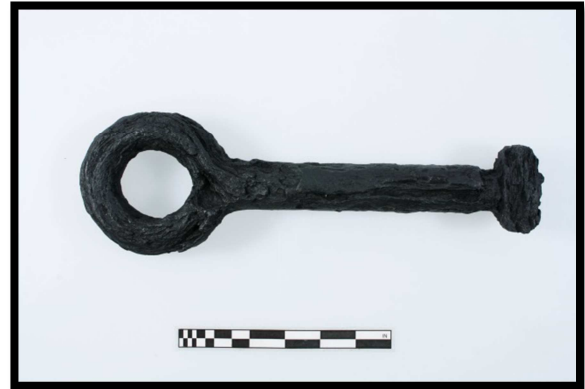
FIGURE 226. EYE BOLT
(ARTIFACT 122-048; SCALE INCHES)

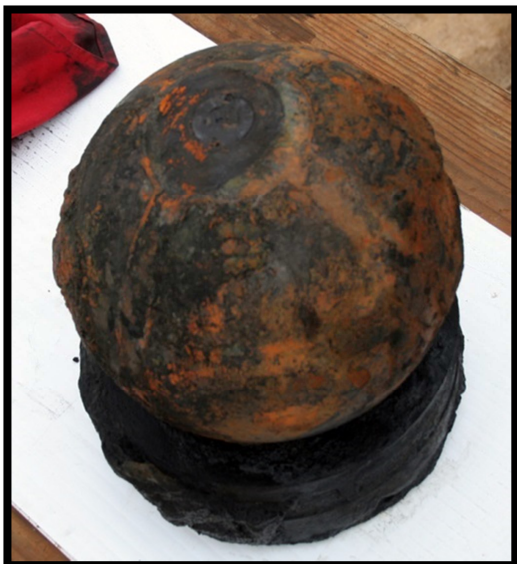
FIGURE 229. 9-INCH SHELL ON SABOT
(PHOTOGRAPH BY AMY BORGENS)

Four of the 9-inch shells were concreted to their respective sabots (e.g., Figure 229), including one recovered from the base of the cannon's bore. Wooden sabots were affixed with tin straps to the base of each shell, opposite the fuse. Remnants of tin straps and a tin band around the fuse can be seen in Figure 229 as a slight stain on the shell. Tack holes where tin straps were fastened to the edge of a sabot can be seen in the side view of Figure 230. The alignment maintained by the sabot and straps kept the fuse pointed away from the firing charge, hopefully assuring the shell did not ignite while in the muzzle. Iron concretions protected the surviving sabots from *teredo* consumption, including a fused 9-inch shell on a sabot inside a wooden passing box (Figure 231), one of the best examples of wood preservation in the artifact assemblage. Another 9-inch shell (Artifact 121-002) was discovered concreted to a sabot, with a wooden plug in its fuse hole, and stored inside of a passing box. Passing boxes were used to temporarily store shells while passing them up to the gun deck. The fact that the latter shell had not been fused suggests it was stored in the aft magazine when the ship was destroyed.

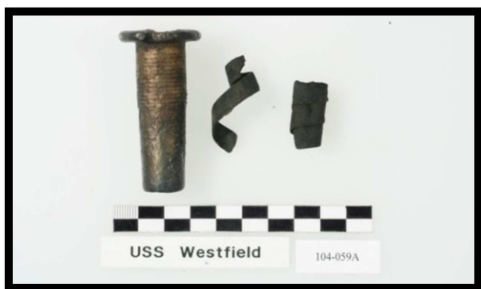
FIGURE 233. FUSE AND PAPER WICK
(ARTIFACT 104-059A)

Seventy-one brass fuses have been identified within the artifact collection. All the fuses are the standard U.S. Navy watercap type issued for naval shells (Figure 232, for example). The watercap fuses were an improved version of the naval fuse designed by Cyrus Alger and used during the Mexican-American War. The timing mechanism, or wick, inside each brass fuse consisted of a tightly wound plug of paper infused with gunpowder (Figure 233). The burn time of each fuse was controlled by the length of the paper wick.

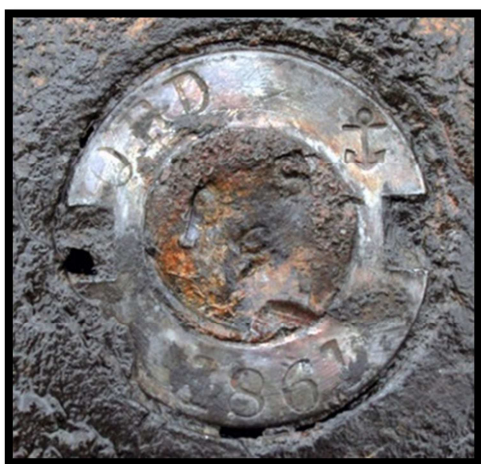
FIGURE 234. LEAD SAFETY PATCH
ON 5-SECOND FUSE
(PHOTOGRAPH BY AMY BORGENS)

A watercap that prevented moisture from entering the fuse was sealed by a lead safety patch stamped with the burning time in seconds (Figure 234). Twenty-one fuses retained their lead safety patch with burning times of 5 and 15 seconds clearly legible. Slightly more than half of the lead fuse caps recovered from the site came from fused shells, which appeared to offer a more protective environment due to their relatively stable positions. The lead would have been removed from a fuse shortly before firing a shell, as the fuse was ignited by the muzzle flash. For example, the fused shell in the Dahlgren bore did not have a lead cap in place, despite the protection afforded by its location.

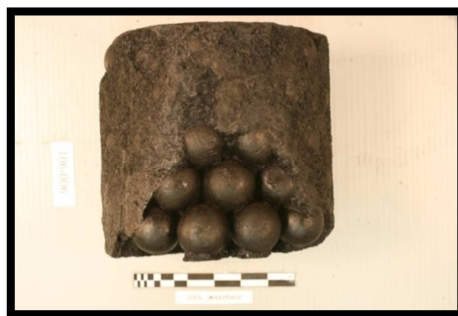
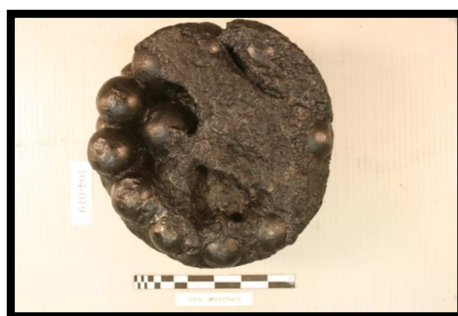
FIGURE 237. CANISTER SHOT EXAMPLES
(ARTIFACT 106-006 TOP;
104-019 BOTTOM; SCALE INCHES)

Ten complete or partial canister shot have been identified. Diameters of shot represented include 1.3 and 1.5 inches. Several of these were recovered with portions of their outer tin casing intact. One of the best-preserved examples of a complete canister shot (Artifact 121-48) is shown prior to conservation in Figure 235. It measures 7.3 inches long and has a diameter of 7.9 inches. The tin casing does not generally survive conservation. Figure 236 shows the same artifact disassembled after conservation. Only a small fragment of tin survived. This canister contained 86 solid iron shot. Two other conserved examples (Figure 237) illustrate how solid shot was packed in sawdust within the canisters.

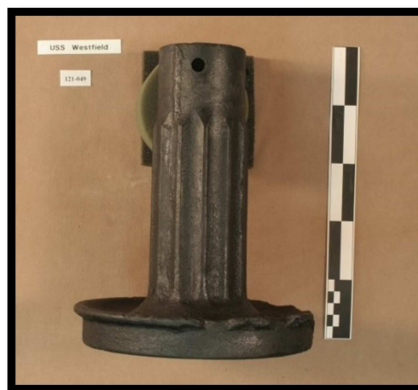
FIGURE 238. GRAPE SHOT STAND
(ARTIFACT 121-049; SCALE CM)

Grape shot was much less common than canister shot in the artifact assemblage. Only five examples of iron shot were large enough that conservators classified them as grape shot. An empty iron stand, designed to hold grape shot for a 9-in Dahlgren, also was recovered from *Westfield* (Figure 238). It was found concreted to a 2.5-in solid shot and fragments of rope and canvas. The maximum diameter of its base, if not damaged, would have been 8.56 inches. Grapeshot for the naval 9-inch Dahlgren was held in place by a "quilted" sailcloth enclosure and measured 10.75 inches in length with a diameter of 8.65 inches. The standard diameter grape shot for the 9-inch quilted round is 2.80 inches (Bell 2003:99, 109).

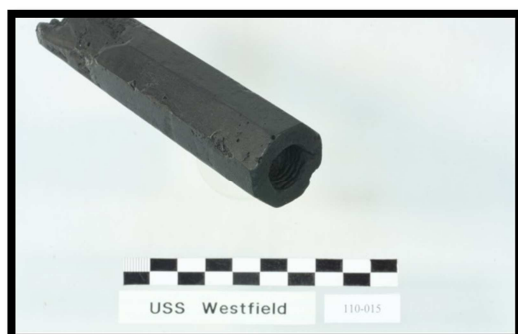
FIGURE 240. BREECH END OF FIREARM BARREL
FRAGMENT (ARTIFACT 110-015)

A second firearm fragment (Artifact 110-015; figures 240 and 241) is only the rear portion of the barrel at the breech where it fastened to the breech plug. The breech plug is not preserved but remnants of it were attached to the barrel and observed by conservators. The octagon-shaped barrel fragment has a length of 5.13 inches and has a maximum width of 1.00 inch. The rear of the barrel was threaded for its attachment to the breech plug and has an interior diameter of approximately 0.63 inches at this juncture. A lead shot recovered from inside the barrel with a fragment of wadding (Figure 242) has a diameter of 0.37 to 0.41 inches. The wadding consists of a plain fine weave. The fibers are heavily impregnated with iron and dirt. Cleaning this material would have damaged the fibers and separated the weave, so it was preserved with silicone oil without further treatment. The fibers are short and appear to be cotton or linen, most likely cotton.

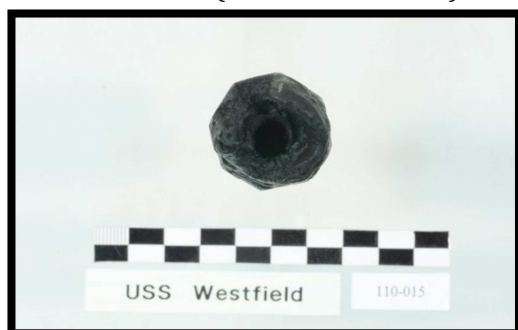
FIGURE 241. BROKEN END OF FIREARM BARREL
(ARTIFACT 110-015)

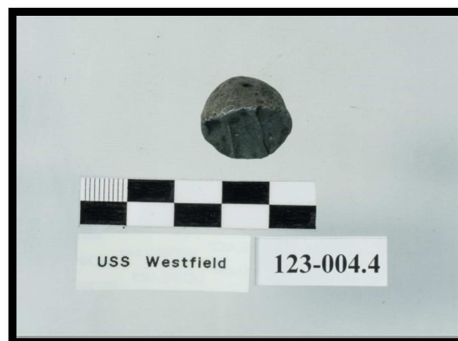
FIGURE 243. LEAD MUSKET SHOT
(ARTIFACT 123-004.4)

A second damaged lead shot (Figure 243), of which just more than half remains, was recovered from grid 123. Artifact 123-004.4 was cut in half, which has had the effect of creating an irregular diameter varying from 0.63 to 0.75 inches. This size of projectile, though damaged, is consistent with musket caliber shot of the period.

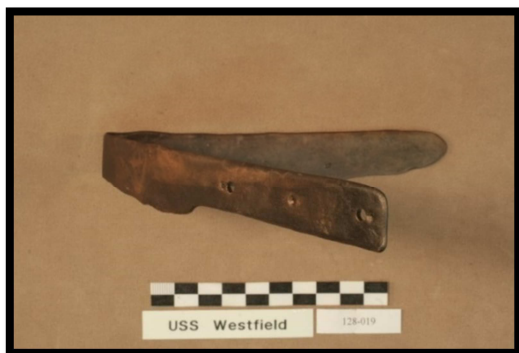
FIGURE 244. COPPER POWDER KNIFE
(ARTIFACT 128-019)

A copper knife was recovered from Unit 128 (Figure 244). This is a rather unique artifact, as most knives of the time would have been made of much harder steel. Copper knives were part of the standard tool kit supplied to each powder magazine. The Ordnance Instructions for the United States Navy, Tables of Allowances of Ordnance Equipments and Stores lists an allowance of one copper knife for each magazine (U.S. Navy Department, Bureau of Ordnance 1864: cii). Given that the forward magazine exploded, this knife must have come from the aft magazine. The fact that it survived in good condition, minus its wooden handle, suggests that no explosion occurred in the aft magazine.

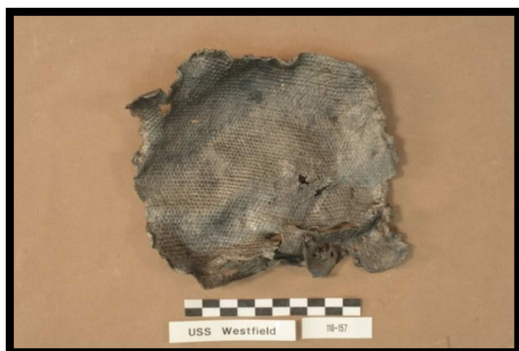
FIGURE 245. LEAD SHEET WITH FABRIC
IMPRESSION (ARTIFACT 118-157)

Over one-hundred miscellaneous fragments of lead were recovered from *Westfield*. While many were intrusive fishing weights, the purposes of others could not be determined. Most of the recovered lead appeared as non-diagnostic scraps of metal. Of the few that did contain diagnostic features, only one can be potentially recognized as having a specific function. The lead sheet shown in Figure 245 contains a unique impression resembling a fabric weave, providing a clue as to its function. The Union Navy lined powder magazines aboard naval vessels with lead to prevent accidental sparking (U.S. Navy Department, Bureau of Ordnance 1864: III-48). Coarse woolen baize cloth was hung as a screen over entrances to prevent sparks from entering the magazine. The imprint might have been caused by stacking powder barrels on a woolen baize cloth laid down on the magazine floor or by stacking woolen powder cartridge bags directly on the lead sheeted floor.

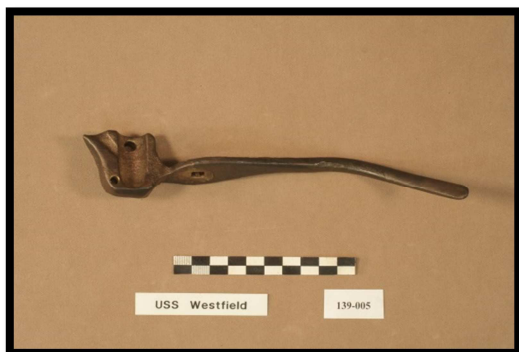
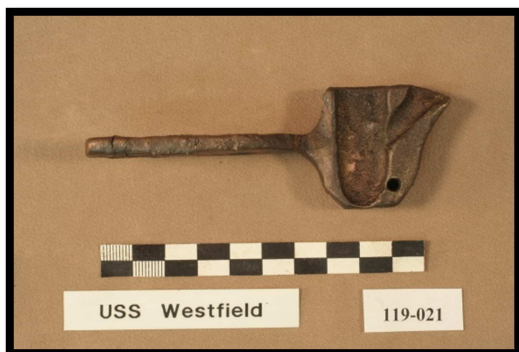
FIGURE 246. BULLET MOLD
(ARTIFACTS 139-005 AND 119-021)

A hand-held brass bullet mold was recovered in two pieces from grids 119 and 139 (Figure 246). The right half of the mold is complete though the handle is bent (Artifact 139-5). The handle is broken on the left half of the mold (Artifact 119-21). The length of the complete half is 7.5 inches. The handles likely had wooden grips and may have been similar to a locally produced mid-nineteenth-century example from the Gillespie County Historical Society on display at the Bob Bullock Texas State History Museum in Austin, Texas. The mold would have created a conical-shaped lead projectile approximately 1.35 inches long with a diameter of 0.60 inch.

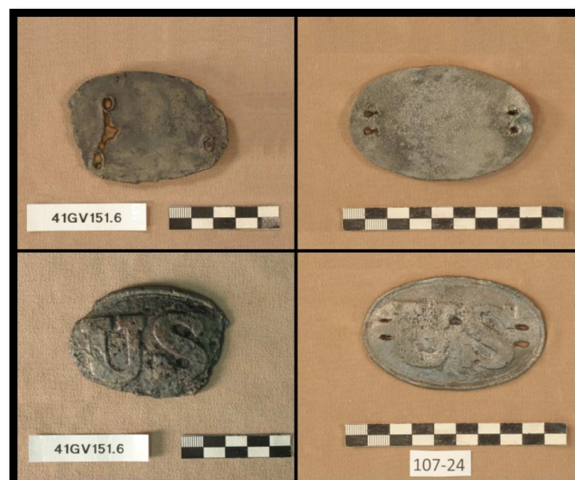
FIGURE 247. EXAMPLES OF UNION BELT AND
CARTRIDGE BOX PLATES
(ARTIFACTS 6 AND 107-024)

Eleven plates were dispersed in the northern portion of the wreck site. Six plates were used on cartridge boxes and 5 plates are the standard U.S. military buckles (typically the Model 1856) issued for belts. Figure 247 displays examples of “U.S.” marked belt and cartridge box plates, differentiated by the different types of clasps either on the back or sides of the plate. Those marked with the “U.S.” symbol appear to be lead but once had a shell of brass overlaid above the lead. Traces of this cupreous material can still be seen on closer examination. The buckles from the cartridge boxes are all complete. All but one of the belt buckles is heavily eroded and damaged.

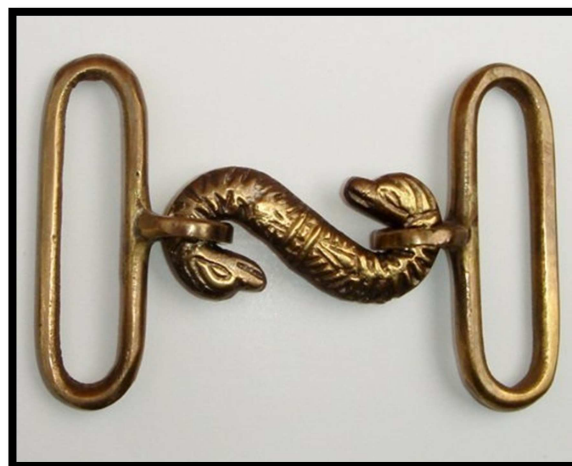
FIGURE 248. REPRODUCTION EXAMPLE OF SNAKE
BUCKLE (UNKNOWN PHOTOGRAPHER)

The British blockade runners supplied the Confederate troops with snake or “S” shaped buckles, which were attached to two oval links on either side of the “S” (Figure 248). Two heavily eroded pieces (Artifacts 111-064 and 135-003) of this buckle type were found on the *Westfield* site and may have been taken off a British blockade runner, as the Union personnel were not above using British plates also (Figure 249). Since these artifacts were not found together, archeologists cannot confirm if the pieces represent two separate buckles or one buckle that became dispersed following *Westfield's* explosion. The midpoint of one long side on the belt plate loop shows a weld point, and the metal is thicker at that point. In addition, a break point is seen next to the weld point. This is most likely the original attachment to a small circular loop where the snake buckle would have attached. Another identical loop on the other side of the snake belt plate would have completed the attachment to the belt.

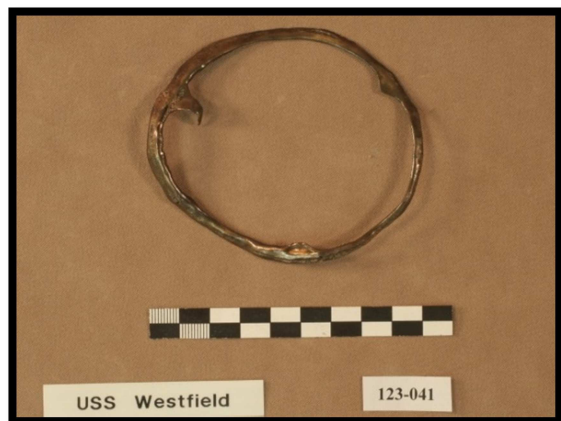
FIGURE 250. BRASS BUCKLE FRAME
(ARTIFACT 123-041)

One other artifact resembles a buckle (Artifact 123-041). Unfortunately the piece is poorly preserved and only survives as an outer frame. The frame may have held a decorative item as indicated by three triangular tabs that line the interior, similar to the image in Figure 250.

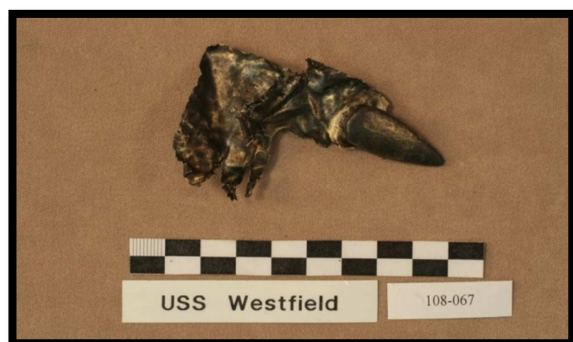
FIGURE 251. BRASS HOOK FOR BAYONET FROG
(ARTIFACT 108-067)

Only a few other clothing artifacts were recovered from *Westfield*. Most of these came from military equipment. Artifact 108-067 consists of a small brass hook and plating that once wrapped around a bayonet scabbard (Figure 251). As seen in Figure 252, the hook was used to attach the bayonet scabbard to a leather belt accessory known as a frog.

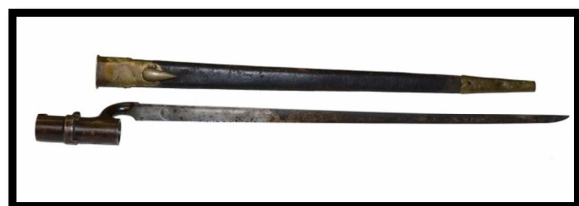
FIGURE 252. COMPARATIVE EXAMPLE OF AN INTACT
BAYONET SHEATH WITH BRASS FROG ACCESSORY
(IMAGE COURTESY OF "THE HORSE SOLDIER")

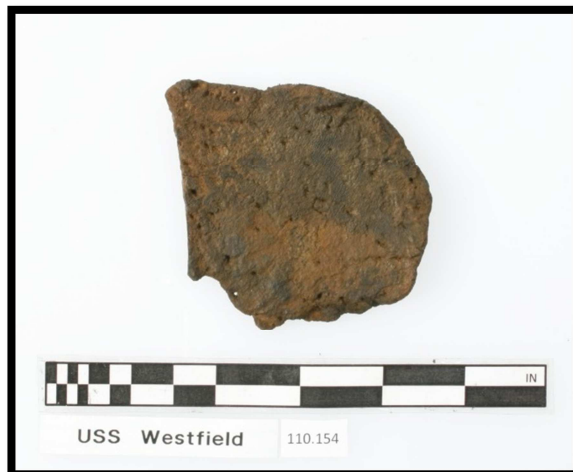
FIGURE 255. LEATHER HEEL FROM LEFT SIDED
BOOT (ARTIFACT 110-154; SCALE INCHES)

At first, Artifact 110-154 appeared as a scrap of non-diagnostic leather. Only after conservation did stitching holes and cut edges become apparent. This artifact proved to be a left heel from a leather boot (Figure 255). During the Civil War, most soldiers' footwear did not contain a proper left or right, which allowed a shoe to be worn on either foot. The indication that this artifact belonged to a left sided sole, may mean that the boot once came from an officer.

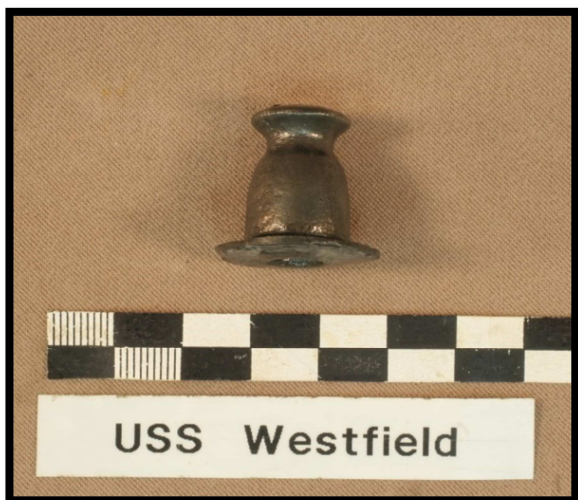
FIGURE 258. BRASS TOP AND CAP FROM
ENFIELD OIL CAN (ARTIFACT 132-001.02)

Marines aboard *Westfield* were issued standard oil bottles to maintain and lubricate their Enfield muskets. Although heavily eroded, a brass top and cap (Artifact 132-001.02) from one of these bottles survived (Figure 258). In original form, the oil bottle contained a rolled sheet of zinc for the bottle and a threaded brass top and cap. The cap contained vertical grooves along the rim to allow for easy fingertip removal. Attached to the inner cap, a steel applicator allowed oil to be removed and applied to the musket (Figure 259).

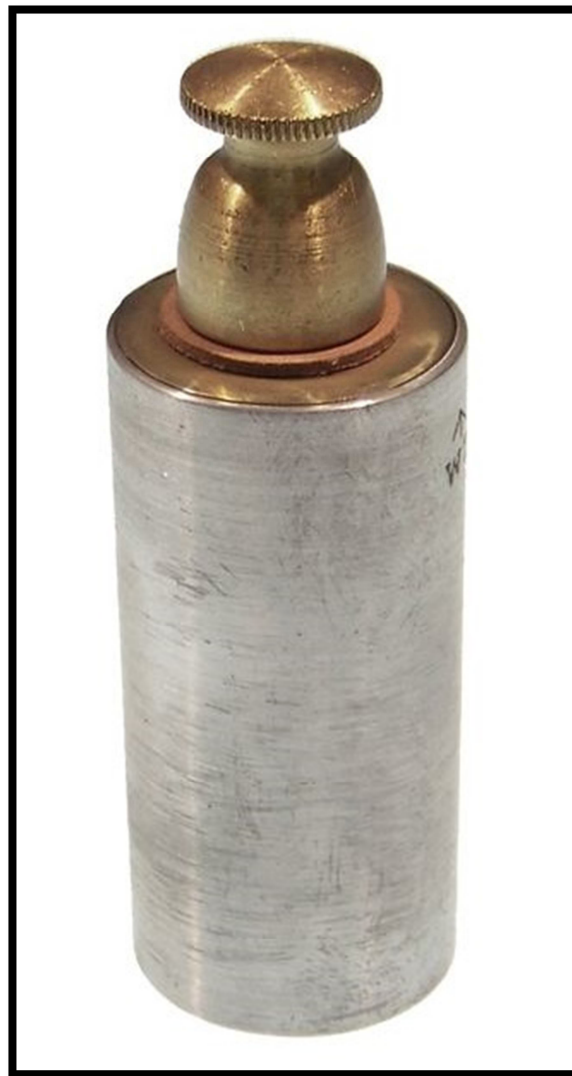
FIGURE 259. REPRODUCTION ENFIELD OIL CAN
(IMAGE COURTESY OF S & S FIREARMS)

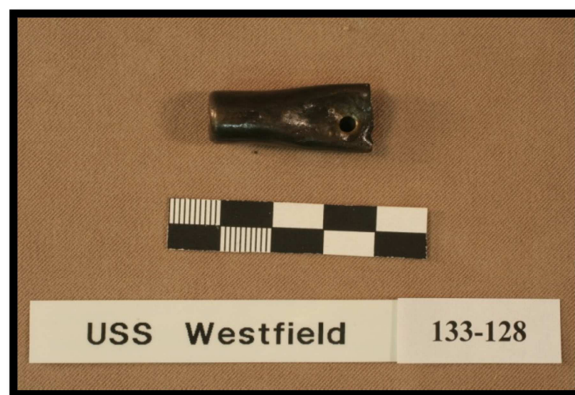
FIGURE 260. BRASS CYLINDER FROM ENFIELD
MUSKET ROD (ARTIFACT 133-128)

Part of maintaining an Enfield musket, included running a ramrod down the barrel with a cleaning jag to swab out debris. A fitting from one of these rods was recovered from *Westfield* (Artifact 133-128). This fitting consists of a small brass cylinder with internal threading on one end and two small pin holes on the other. These pin holes pierce through the cylinder's diameter. The side with the holes is crushed, but the rest of the artifact is relatively well preserved. The artifact was designed to secure a brush or cleaning jag to the rod. The internal threading allowed the cleaning jag to be screwed onto the rod's tip. To secure the cylindrical fitting to the rod, a small iron pin was pushed through the holes in both the fitting and the rod (Figure 260).

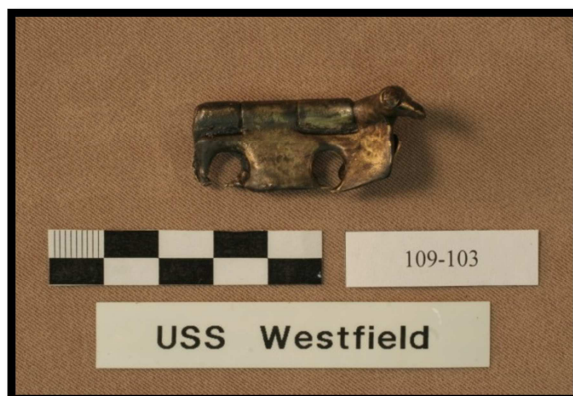
FIGURE 264. INTACT BRASS HINGE
(ARTIFACT 109-103)

An assortment of other artifacts may have come from seaman's storage chests, foot lockers, or other types of boxes. All of these artifacts are cupreous and were found scattered across the site. As with other artifacts, this disarticulation does not allow archeologists to determine with certainty how many original objects are represented in the collection. Despite this, four hinge fragments (Artifacts 102-062, 105-023, 106-031, and 107-028.1) are of the same size, and design, and if joined represent two complete hinges with an upper and lower portion (Figure 263). These fragments appear to have come from the same original object. One other hinge (Artifact 109-103) of a different type came from a different object (Figure 264).

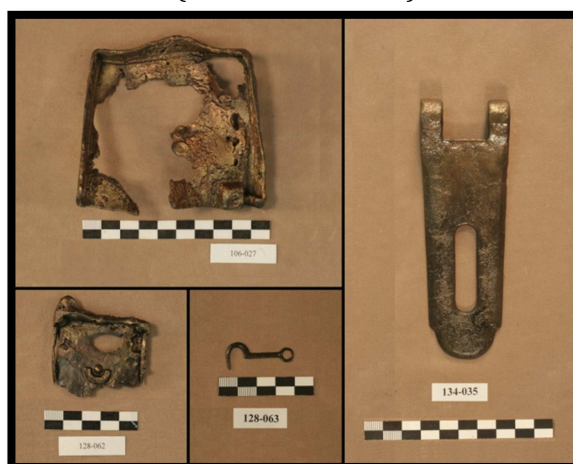
FIGURE 265. ASSORTMENT OF BRASS LOCKING
DEVICES (ARTIFACTS 106-027, 128-062,
128-063, AND 134-035)

Four locking devices were also found (Figure 265). A cupreous hasp (Artifact 134-035) for a padlock clasp contains two holes on one end. One of these holes is filled with brass, suggesting that the other portion of the hasp was also made of brass. The other end has decorative beveling, flat on one side and concave on the other, and a long ellipse opening to allow a loop to enter and a lock to be attached. Another lock type consisted of a small hook with a flat backside and a decorative embossed front (Artifact 128-063). The hook was once fixed to a box and rotated counterclockwise, so that the embossed side faced outward.

The other locking devices consisted of fragments from two different sized rectangular lock plates. The larger lock plate (Artifact 106-027) contains mounting points suggesting that the artifact came from the back portion of a lock assembly. The smaller lock plate (Artifact 128-062) contains an oval or key entry that indicates that the object is from the front of a lock assembly. Falling into the same category as locks, a small cupreous key (Artifact 120-295) was recovered but cannot be confirmed

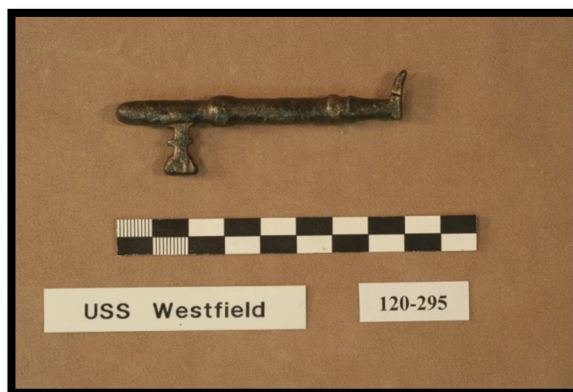
FIGURE 266. BRASS SKELETON KEY
(ARTIFACT 120-295)

as belonging to one of these boxes or from one of the ship's doors (Figure 266). The key contains three decorative bands around the shaft and is mostly complete, with the exception of a missing portion of the ring.

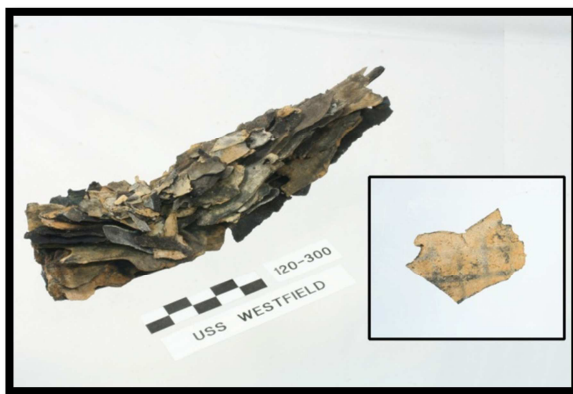
FIGURE 268. BURNED BOOK WITH BRASS SPINE (ARTIFACT 120-300)

One of the most surprising personal artifacts discovered, consisted of burned paper pages and what appears to be a brass book spine (Artifact 120-300). Although burned almost beyond recognition, the surviving fragments of this book are remarkable considering the violent destruction of *Westfield* (Figure 268). One small fragment revealed grid marks and possible numbers indicating that the object may have once been a ledger of sorts.

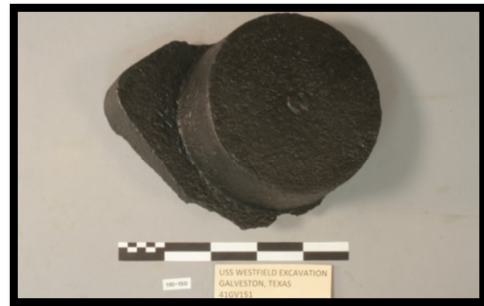
FIGURE 271. LARGER CYLINDRICAL NAVAL STOVE COVER (ARTIFACT 110-150; SCALE CM)

To feed *Westfield's* large crew, the vessel required a shipboard kitchen or galley. Two small cast iron artifacts were recovered from what is believed to have been the starboard central side of the ship. Conservators believe that both of these objects served as cover plates from a large marine stove located near this vicinity of the wreck site. The larger artifact (110-150) contains a square base that is largely damaged, but rounded corners and a central raised circular portion indicate that the object was designed to fit over something without moving (Figure 271). Similar examples from 1835 can be found in French naval stoves for shipboard use (see Figure 272). These stoves contained built-in cylindrical recesses into which pots were placed. When not in use, square and round cover plates covered these recesses. The smaller artifact (119-126) was once part of a round cover plate that if complete, contained an internal diameter of approximately twelve inches (Figure 273). If these artifacts are close to their original position, *Westfield's* kitchen may have been situated on the starboard side of the vessel.

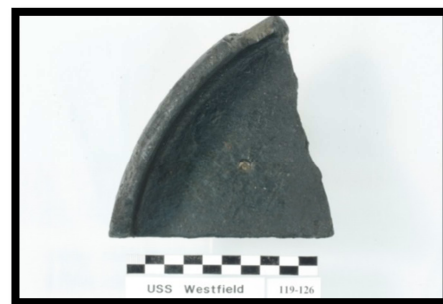
FIGURE 273. SMALLER NAVAL STOVE COVER (ARTIFACT 119-126)

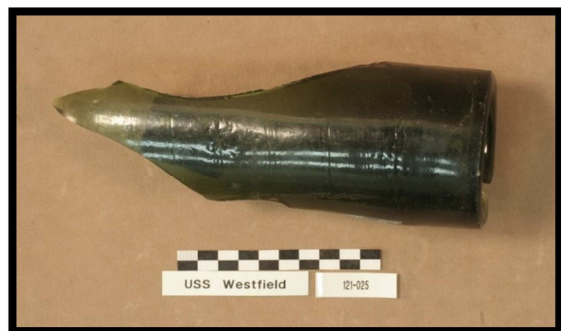
FIGURE 275. DARK GREEN WINE BOTTLE (ARTIFACT 121-025)

Several fragments of light green glass were recovered from *Westfield*. The largest piece (Artifact 121-025), represents a one-third surviving section of a wine bottle (Figure 275). The glass is thick and heavy, and is missing the neck, rim, and most of the body. Significant portions of the base and kick-up are still intact. The breaks in the bottle show that unlike modern bottles, these 19th-century bottles have many imperfections, such as uneven wall thicknesses and bubbles contained within the glass. Several fragments were also found of darker green glass. The largest piece consisted on only the lower base (Artifact 132-396). This bottle contains very thick heavy glass that is opaque (Figure 276). Only the base, kick-up, and a small portion of walls are preserved. The kick-up has low sloping walls that are almost at 45 degrees from the walls of the bottle. A small, shallow pontil scar is visible on the outside showing from where the bottle was blown.

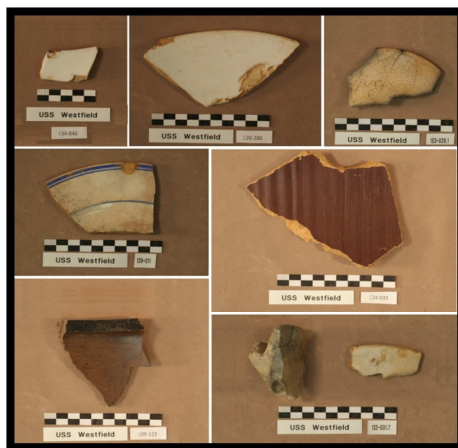
FIGURE 278. MISCELLANEOUS CERAMIC SHERDS (ARTIFACTS 134-046, 120-280, 103-039, 139-011, 124-033, 109-123, AND 132-001.7)

The following fragments represent the most diagnostic or largest examples of different ceramics types recovered from *Westfield* (Figure 278). Artifact 134-046 consists of a small porcelain rim sherd. This fragment has a bend on the opposite end of the rim, where the original object may have sloped downwards to create the concave lower portion of a plate or bowl. Artifact 120-280 is one of the largest surviving ceramics in the collection. This sherd came from an ironware plate or platter that contained an original diameter of approximately 12.59 inches. The side opposite of the rim bends to slope down into concave lower portion of the plate. Perhaps the most diagnostic fragment, is Artifact 103-039. This small surviving fragment of whiteware was found by conservators with a fabric impression preserved in the concretion. The impression indicates that original fabric pieces were folded over, and possibly wrapped around the ceramic piece. This suggested to conservators that the plate was protected with a layer of linen while in cupboard storage. Unfortunately, the impression of the cloth did not survive conservation attempts. A second larger whiteware sherd, Artifact 139-011, contained an original plate diameter of approximately 9.84 inches. This plate is decorated with three blue annular lines; two around the edge, one thick and one thin, and one thin line where the sherd bends down into the lower portion of the plate. Artifact 124-033 is the largest ceramic piece recovered from *Westfield*. The stoneware sherd contains an exterior color of tan with a mottled glaze, and on the inner side, a dusky red or maroon glaze with horizontal striations or grooves from the manufacturing turning process. The last two ceramic examples are both sherds of salt-glazed stoneware. Based on their design, these artifacts may have been associated with each other or with other examples of the same purpose. Artifact 109-123 was from the lower body and base of a large rounded pot container. The outer surface is colored light olive gray. The inner surface has streaks of orange and dark brown indicating that the color was unevenly applied with brushstrokes prior to firing. Towards the base, the painted streaks changed from angled to parallel with the base. The second salt-glazed fragment, Artifact 132-001.7, is a small rim sherd from a lid and contains the same colors as the previously mentioned artifact. Although small, the sherd is

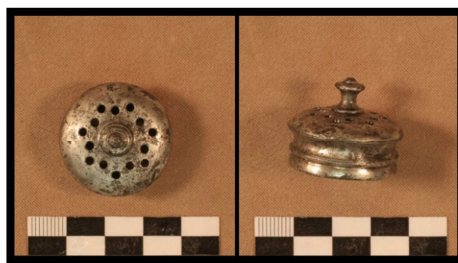
FIGURE 279. ELECTROPLATED SILVER CONDIMENT SHAKER CAP (ARTIFACT 109-010)

Only one example of metal tableware (Artifact 109-010), an electroplated silver condiment shaker cap, possibly for dispensing salt or pepper, was preserved from *Westfield* (Figure 279). Silver was one of the first metals to be electroplated commercially, primarily for tableware. Electroplated silver objects were highly decorative and resistant to attack from fruit acids and other foodstuffs (Canning 1960:383). Few small personal artifacts belonging to *Westfield* are as diagnostic or important as the condiment shaker cap. Such a decorative item may have come from the Commodore's or officers' table. The discovery of the shaker cap was momentous and is a very good example of why x-raying is so important in archeological marine conservation. Weeks of x-raying *Westfield* concretions had yielded little more than a series of bolts, bleeds, and boiler bits. A large bolt, which appeared to have a small radio dense button towards the end, was visible on the x-ray. Further x-rays revealed the shaker cap, which confirmed suspicions that this was something significant.

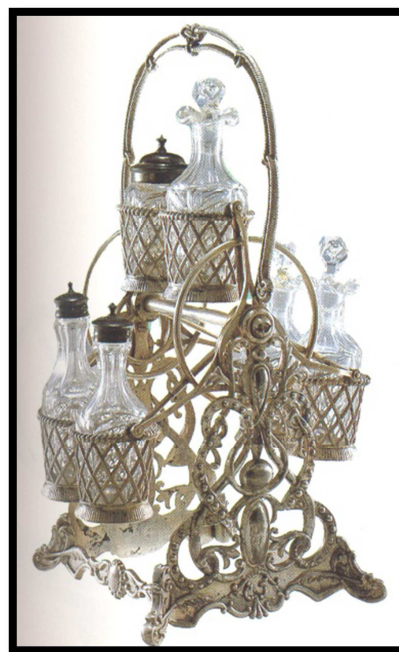
FIGURE 280. EXAMPLE OF A VICTORIAN ELECTROPLATED CRUET MADE IN 1861 (IMAGE COURTESY OF CHANTICLEER PRESS, INC.)

In Donald Fennimore's *American Silver and Pewter* (2000:68), the author lists a Victorian electroplated cruet made in 1861 by the Meriden Britannia Company from Meriden, Connecticut. This example shown in Figure 280 has three free-swinging baskets which rotate a center axel, allowing the items in each basket to be easily reached. While the set from which the *Westfield* shaker cap came from may not have been as fanciful as this, the cap does match others in this set almost identically. The cap most likely came from a glass bottle similar to those shown on the bottom left of Figure 280.

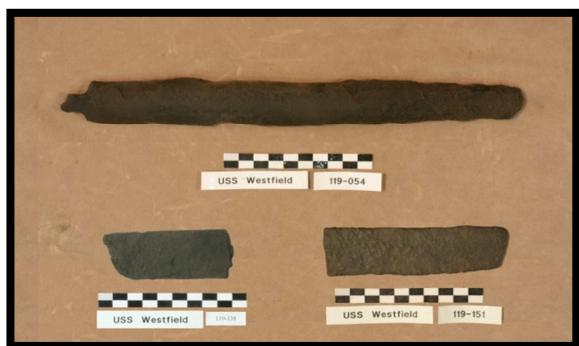
FIGURE 281. CONSERVED FILE TOOLS (ARTIFACT NO. 119-054, 119-151, AND 119-138)

All three of the files were recovered in very poor condition, and required molding and casting to preserve their shape and information (Figure 281). The original artifacts did not survive this process. Following conservation, one of the file casts was mostly complete (Artifact 119-054), and the results preserved a half-round epoxy file from the point to the upper portion of the tang or spike). The majority of the handle did not survive. Teeth were spaced 0.05 inches apart on the front and back face, and along the edges. The flat face contained angled, double-cut teeth, while the rounded face contained angled, single-cut teeth. The other two file casts (Artifacts 119-151 and 119-138) survived only as short fragments, both from the point end of the file, opposite of the tang or spike. These files contained angled, double-cut teeth, spaced 0.04 inches apart on both faces and along their edges.

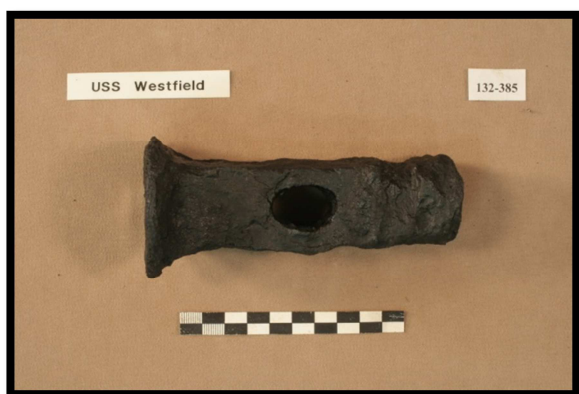
FIGURE 282. WROUGHT IRON HAMMER HEAD TOOL (ARTIFACT NO. 132-385)

The remaining tools from *Westfield* fall into a category of miscellaneous types and uses. A hammer head (Artifact 132-385) was recovered near *Westfield*'s firebox (Figure 282). This places the hammer just south of the grid square in which the files were found, again offering the possibility that many of these tools originally came from the same area of the ship. The hammer contains a square shape that expanded into a rounded striking end. At the center, an elliptical hole once supported a wooden handle, of which two fragments survived. The U.S. Navy issued a variety of hammers to navy ships, including chipping hammers, hand hammers, riveting hammers, and assorted copper hammers (United States Navy Department 1865:26). The type of this particular example is difficult to identify due to the hammer's poor preservation.

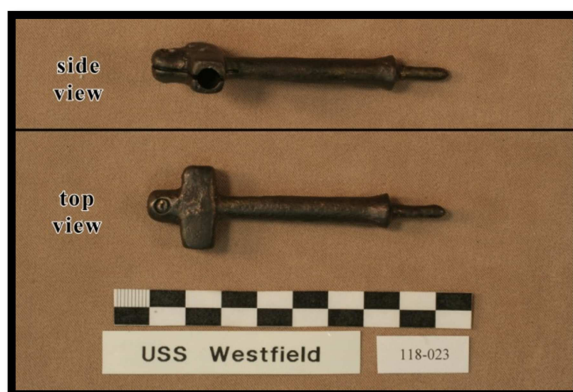
FIGURE 286. BRASS SOCKET TRAMMEL FROM NAVIGATIONAL BEAM COMPASS (ARTIFACT 118-023)

A single brass socket or trammel (Artifact 118-023) survived from a navigational beam compass (Figure 286). Originally, there would have been two of these trammels that slid along a rod in order to widen or shorten the distance between them, when used on a navigational chart. To support the rod, two arms or extensions are hollowed out in the shape of a cylinder on either side of the object, creating a head. Based on this hollowed head, the original rod was also cylindrical and contained a diameter of approximately 0.21 inches. A small slit extends .89 inches from the top of the tool dividing the head into two sections. Piercing through this divided head, a small broken screw was once used to tighten, or secure the trammel at the desired location on the rod. The bottom of the artifact contains a tab that appears to have inserted into another object. Following the example of modern trammels, the broken screw likely ended in a small wheel or thumb screw that could be turned with two fingers, and the tab on the bottom accommodated different end caps that could contain ink, pencil graphite, or needle tips for numerous navigational needs (Figure 287).

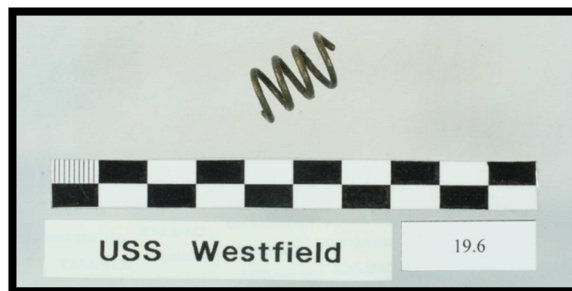
FIGURE 291. SMALL BRASS SPRING (ARTIFACT NO. 19.6)

Excavations recovered five small cupreous springs of equal coil size diameter (Figure 291). The lengths of these artifacts varied between one to two centimeters. The springs all appear to have been clipped to their respective lengths rather than undergoing breakage during site formation processes. How these artifacts were used on *Westfield* is not clear. Conservators found two of the springs within the same concretion, while the remaining three contained proveniences of no apparent pattern. All of the artifacts were found within concretions that contained an assortment of miscellaneous bolts, fasteners and metal fragments. These accompanying artifacts do not appear to have shared any correlation to the springs' original use.

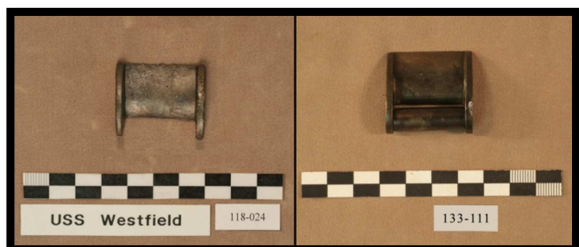
FIGURE 288. BRASS TOURNIQUET BUCKLES (ARTIFACT NO. 118-024 AND 133-111)

Two brass tourniquet buckles (Artifacts 118-024 and 133-111) recovered from the wreck site serve as large reminders that *Westfield* and her crew faced constant danger (Figure 288). Like today, tourniquets were used in the Civil War to stem blood flow in limbs when personnel were injured or about to undergo an amputation. Only certain brass portions of *Westfield's* tourniquets survived. There are several mounting holes on both buckles where pieces have broken away. Originally, the tourniquets contained a rolling arm with prongs that bit into a cloth strap to apply pressure on a limb (Figure 289). Small rust deposits on the mounting holes suggest that the original securing pins were iron and did not survive. Without the pins, the rolling arms became detached on both artifacts, as did one of the cylindrical cloth guides on Artifact 118-024.
